UNITED FIRST PARISH CHURCH (UNITARIAN)

HISTORIC STRUCTURE REPORT

Quincy, Massachusetts

April 1996

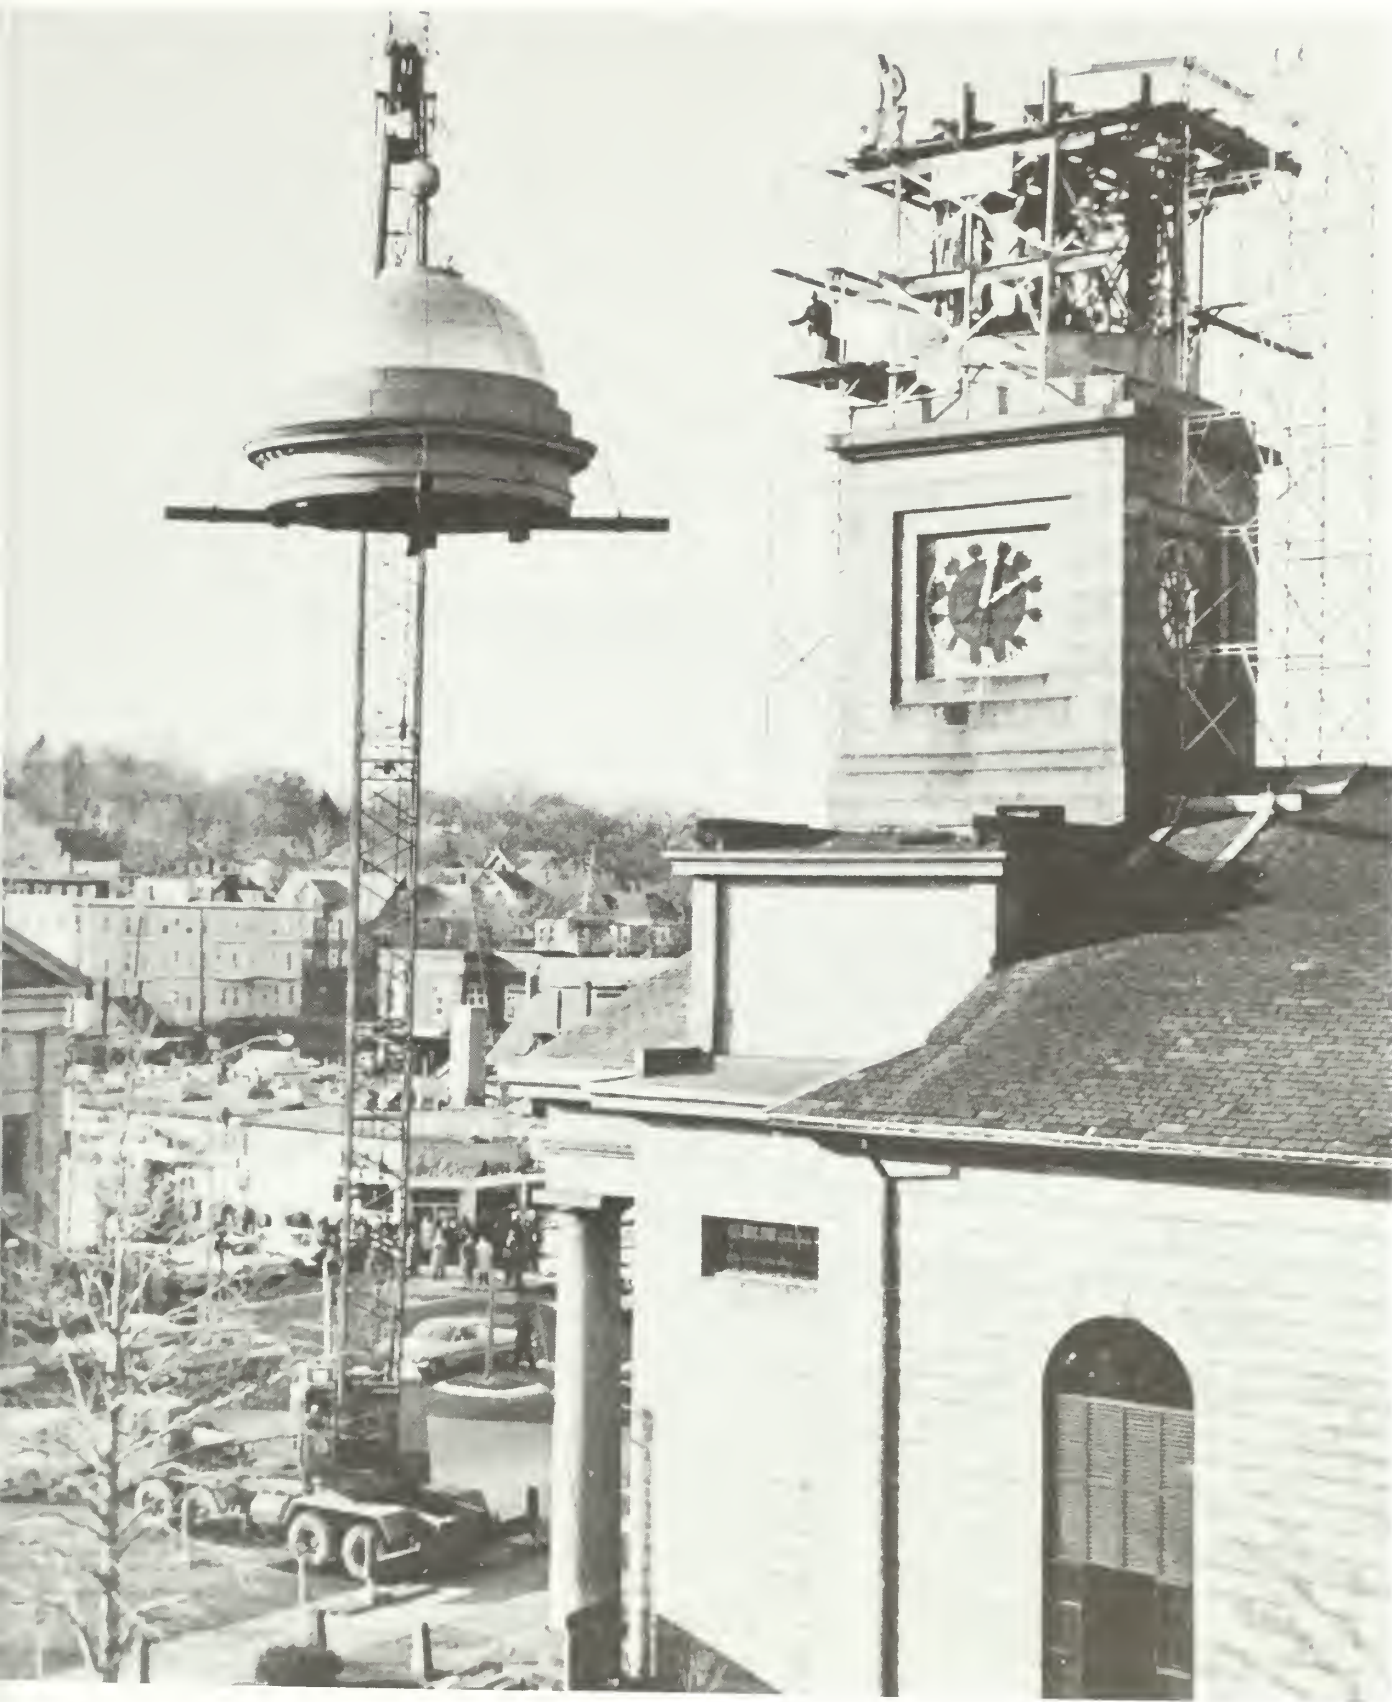
Figure 48. Belfry repairs and dome removal (photograph ca. 1964).

The church committee agreed to follow their suggestion.⁴⁹⁶ MacLeod submitted a proposal to the engineering firm, outlining the removal of the dome, the placement of it on staging at least 6 feet above the ground (see figure 48), and the procedure for removing the wood columns and capitals.⁴⁹⁷

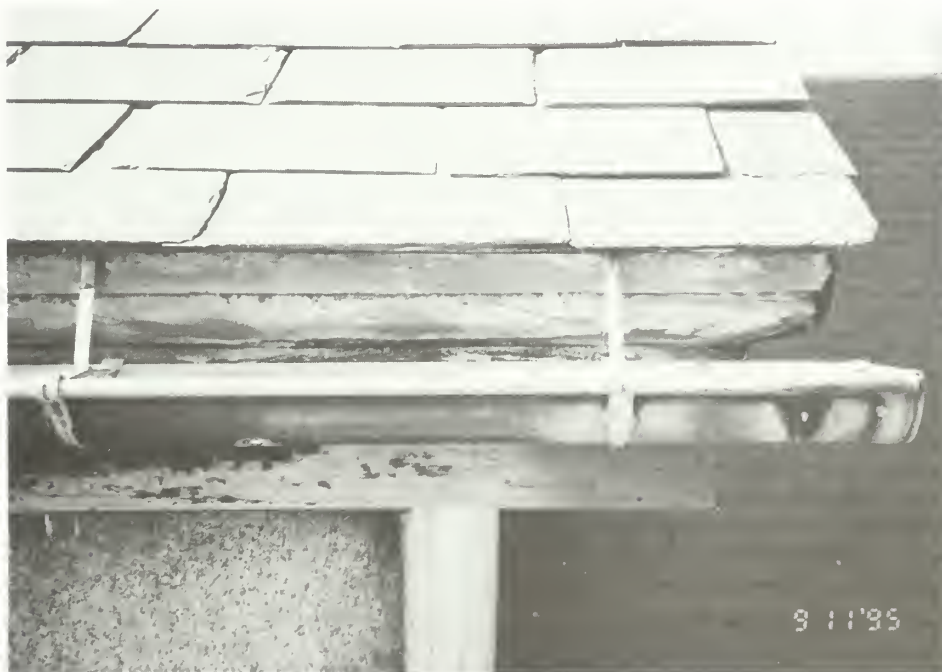
Figure 75. Church exterior: southwest corner of roof, showing hanging half-round copper gutter and rectangular downspout, with oxidation and pitting of the copper.

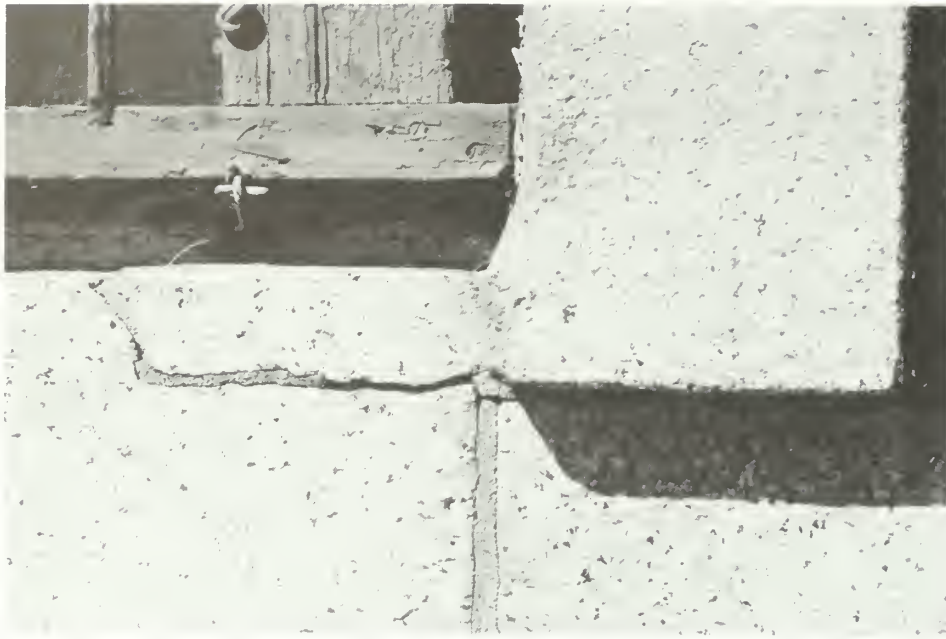
Figure 84. Church exterior: south wall, center window (W103) and basement window (W003).

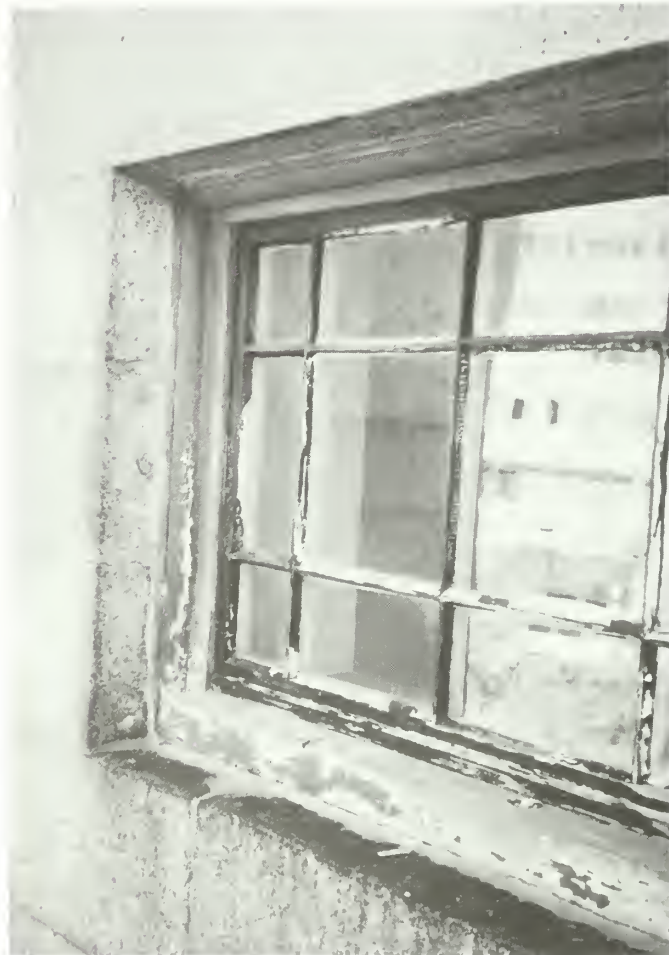
Figure 85. Church exterior: south wall, center window (W103).

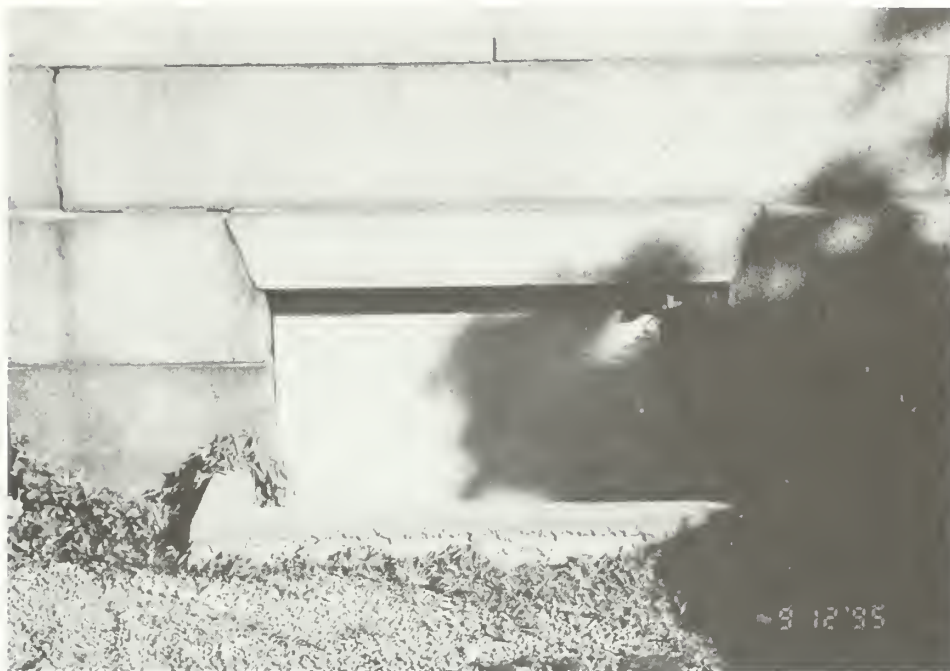
Figure 86. Tower exterior: base, north wall, second-story window (W126).

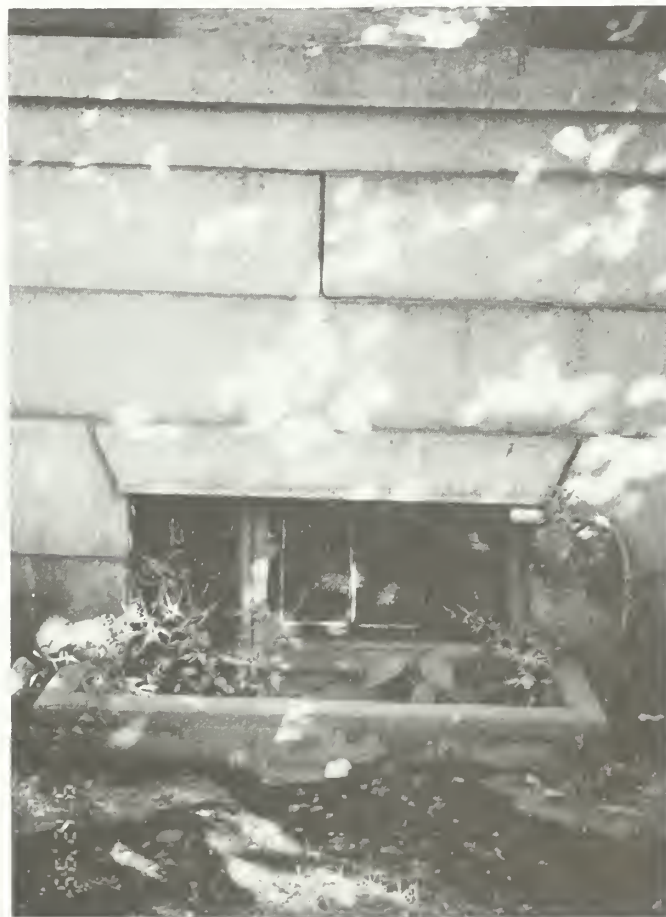
Figure 87. Church exterior: south wall, center basement window (W003).

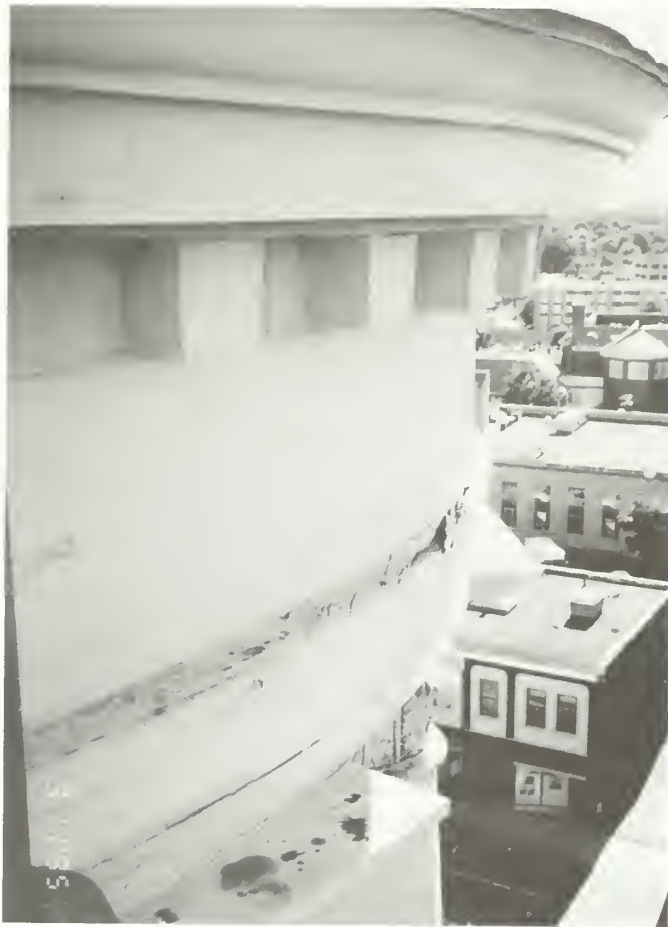
Figure 90. Church exterior: east wall, attic oculus (W302), with loose glazing, peeling paint, open joints; now covered with an exterior thermoplastic sheet.

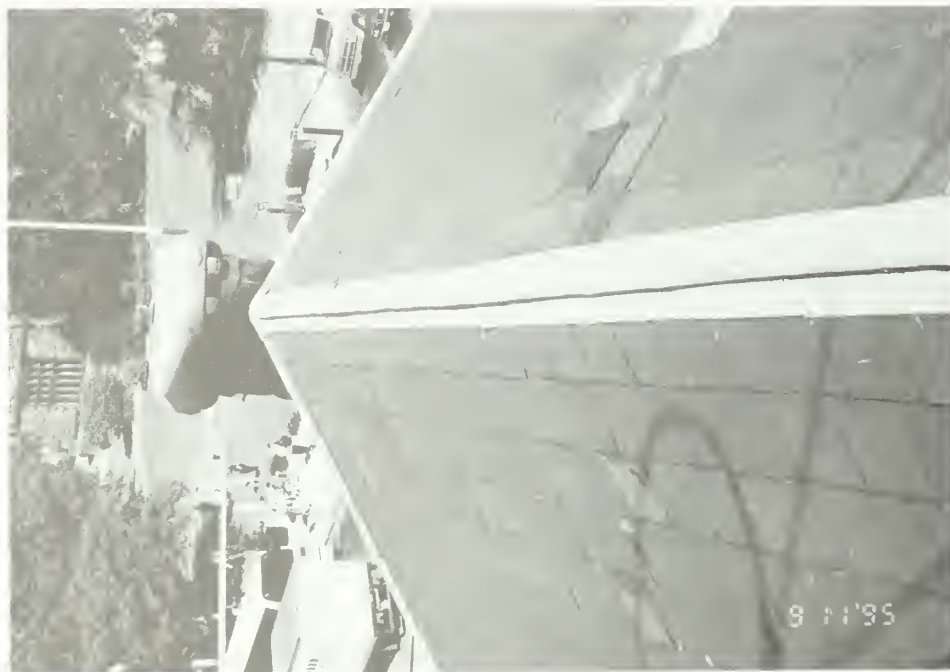
Figure 100. Addition exterior: intersection of north wall with church, showing roof of north porch and lunette window. Note bituminous patches on copper ridge cap and slate roof, clogged valleys, and peeling paint and open joints of window.

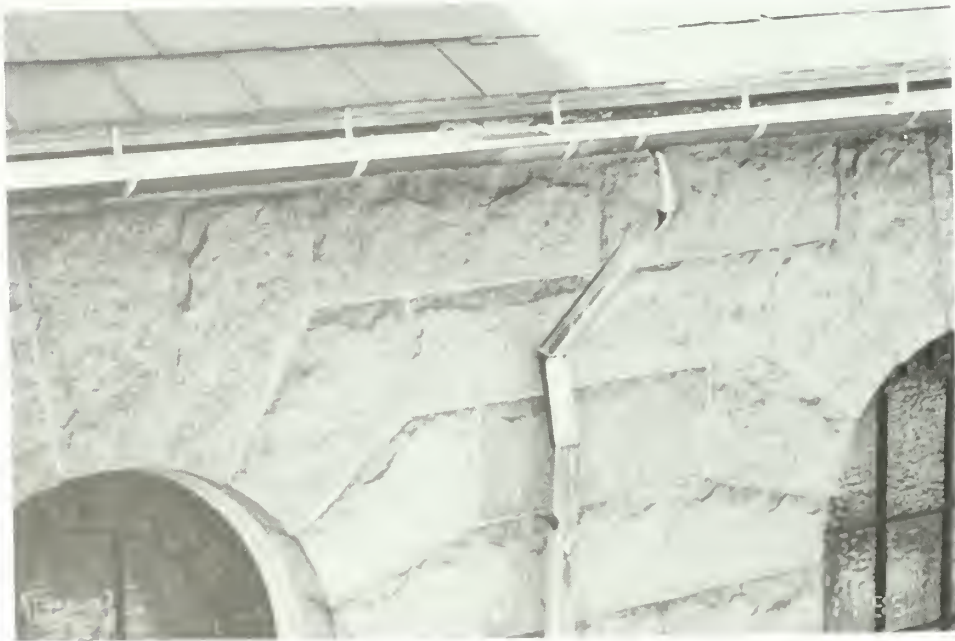
Figure 105. Addition exterior: intersection of north wall and north porch, showing gutter and downspout.

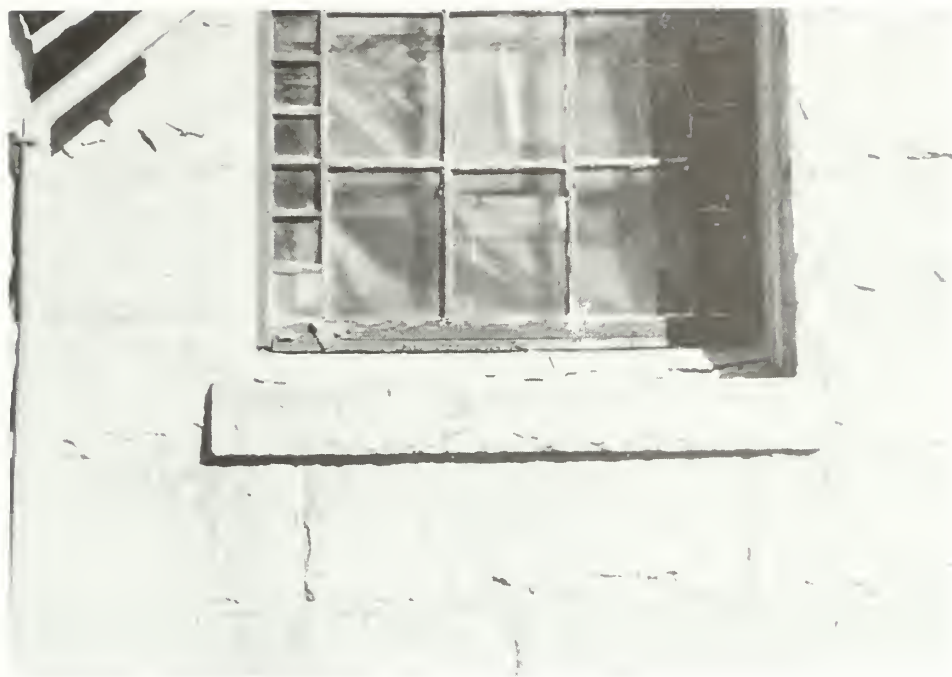
Figure 106. Addition exterior: north wall, gutter and downspout.

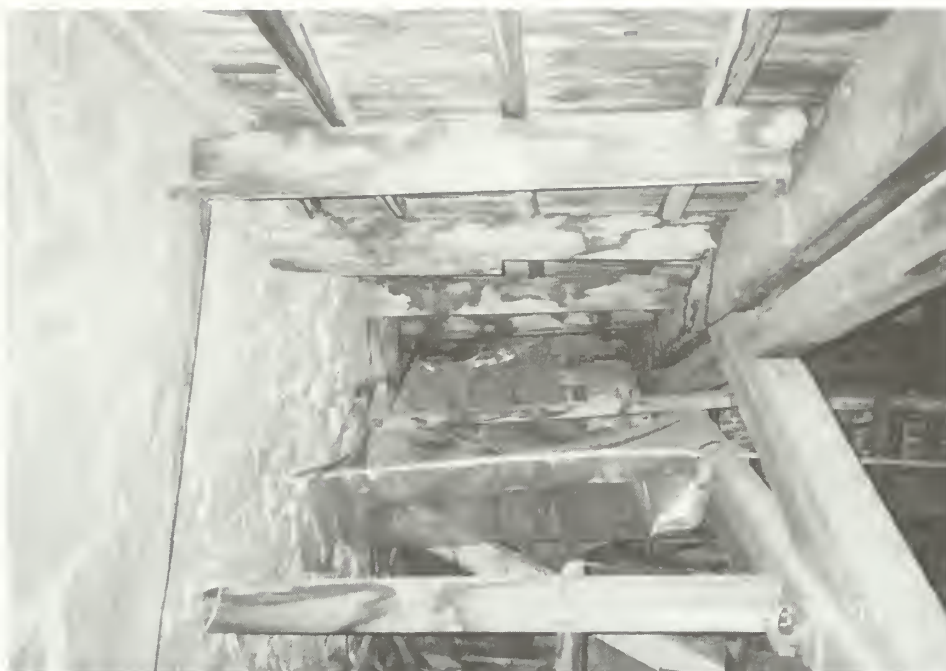
Figure 112. Church interior: attic, north end of east wall, at intersection with sanctuary ceiling. Note repointed mortar joints of wall.

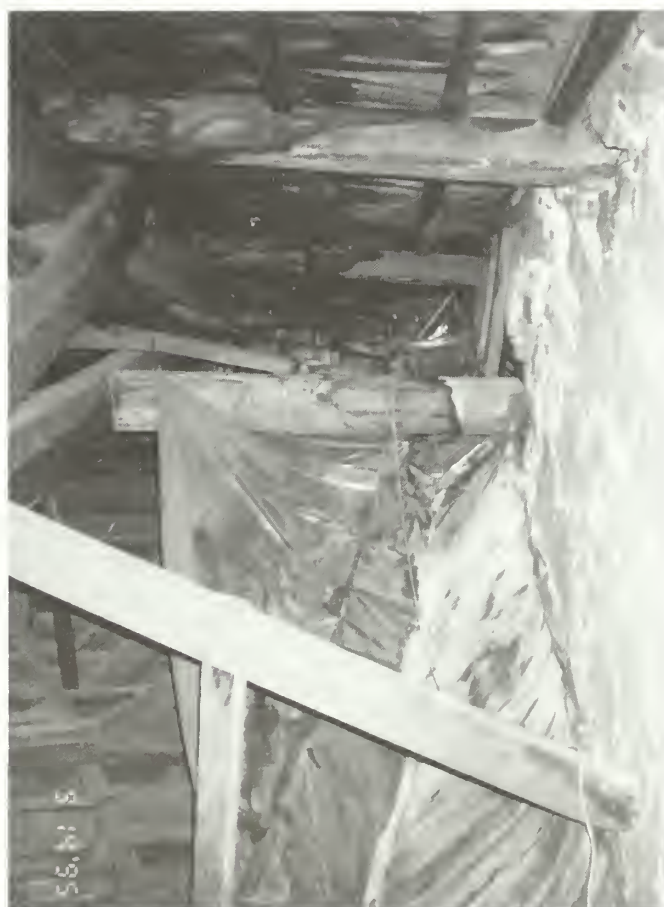
Figure 113. Church interior: attic, north end of west wall, at intersection with sanctuary ceiling.

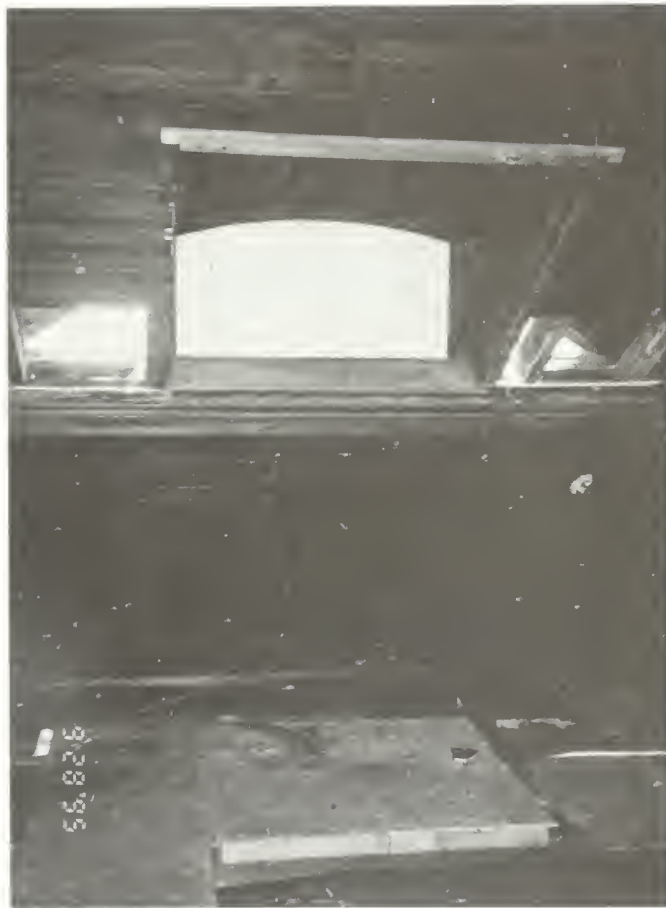
Figure 120. Tower interior: basement crypt south room (Room 003), west wall. Note whitewash peeling from granite wall due to moisture penetration of wall.
